Manhole Inspection Summary

Manhole # S49C__023MH

Insp Date: **6/28/08 9:52 AM**

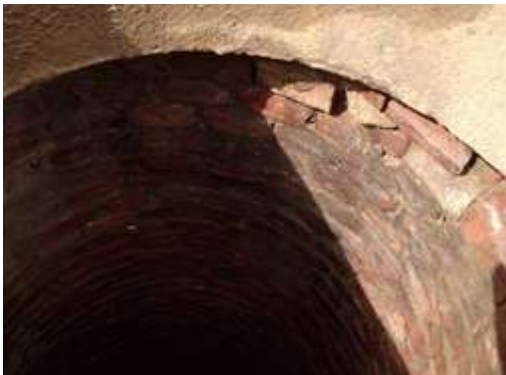
Defect 2

Condition: ☐ Sound ☐ Cracked ☐ Root Intrusion ☒ **Loose Brick** ☐ Deteriorated

loose bricks

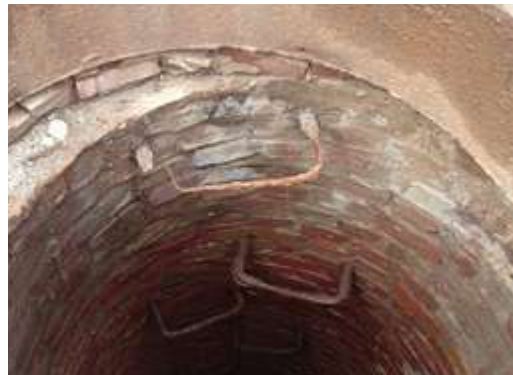
Defect 1

Infiltration: ☐ None ☐ Joint ☐ Cracks ☒ **Mortar** ☐ Roots ☒ **Wall**

infiltration

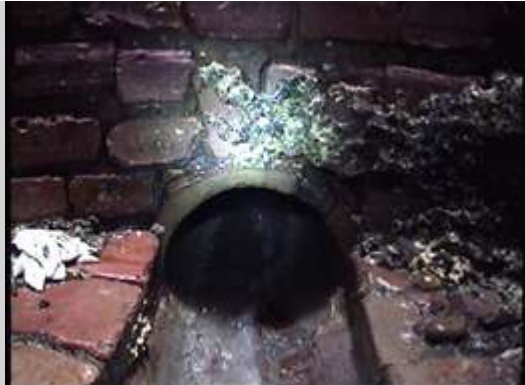
12 O'Clock Outflow

Pipe Height: **8.4** (in.) Rod and Bar (Angled)
Pipe Material: **Clay** ☐ Pipe Lined
Invert Depth: **11.00** (ft.) Flow Characteristics: **Fast**
Deposits: ☒ None ☐ Mud ☐ Sludge ☐ Debris ☐ Grease
Silt Depth: (in.) Deposits Extent:
Infiltration: **None** Pipe Seal Cond: **Sound**

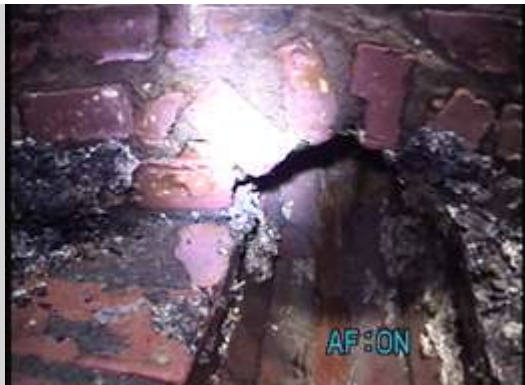
6 O'Clock Inflow

Pipe Height: **8.4** (in.) Rod and Bar (Angled)
Pipe Material: **Clay** ☐ Pipe Lined
Invert Depth: **10.90** (ft.) Flow Characteristics: **Fast**
Deposits: ☒ None ☐ Mud ☐ Sludge ☐ Debris ☐ Grease
Silt Depth: (in.) Deposits Extent:
Infiltration: **None** Pipe Seal Cond: **Sound**

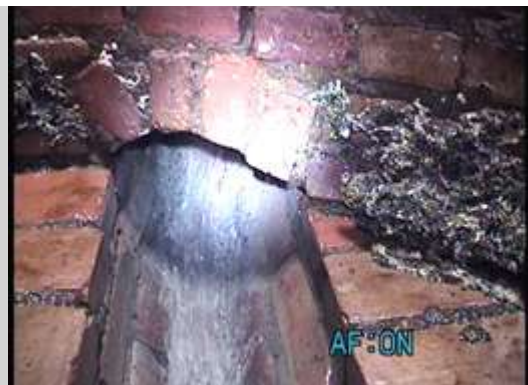
9 O'Clock Inflow

Infiltration: **None** Pipe Seal Cond: **Sound**
